# Investigation of fraudulent arson involving a racing car

M Jones

Capita McLarens, Chartered Loss Adjusters, Heron House, 38 Brazenose St, Manchester M2 5EA, United Kingdom  
A paper presented at the Forensic Science Society Summer Meeting July 2002 '999-Fire, Ambulance, Police—who you gonna call'

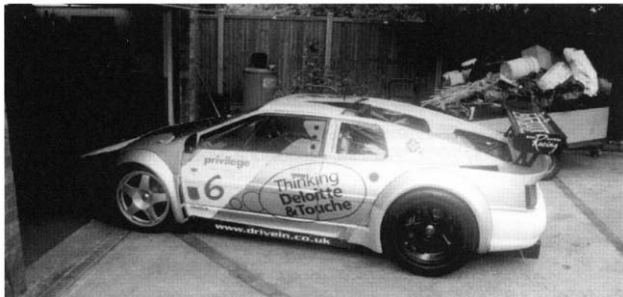
The ideal way to investigate the cause of fire in a car is to have one of the same type available for inspection. Detectives Loftus and Carrington had traced the remaining Esprit GT racer (Lotus only made three of that type) to Mike Haines Racing in Worcestershire. Mr Haines was willing to assist with enquiries and provide a comparison vehicle (Figure 1).

**Figure 1** Nearside of comparison vehicle belonging to Mike Haines Racing.

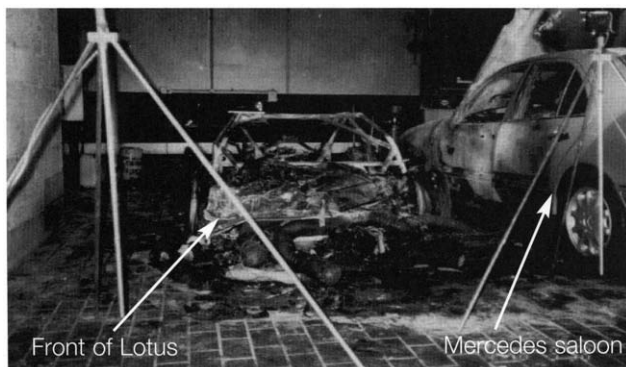
The first task was to determine the arrangement and combustibility of materials within the engine bay. The car had caught fire in a closed workshop and the 'bonnet' had been removed at the time (Figure 2). The fire would have been ventilated by free convection so the fuel loading would have been the primary influence on the development of the fire.

**Figure 2** The Mercedes garage where the Lotus was being prepared for track testing.

"footprint" of the car except where it had spread into the engine compartment of a nearby saloon car (Figure 2). There was no evidence of combustion of a substantial pool of leaked petrol.

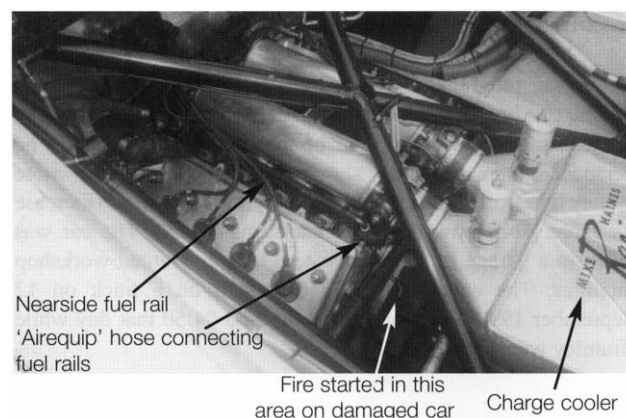
The layout of the engine bay was very simple compared to a 'domestic' motor car (Figure 3). There was no plastic air filter housing, no plastic oil drip tray or engine cover, no power steering gear nor large washer bottles. There was simply an aluminium engine block with aluminium air circuit components,

**Figure 3** Engine bay of comparison vehicle.

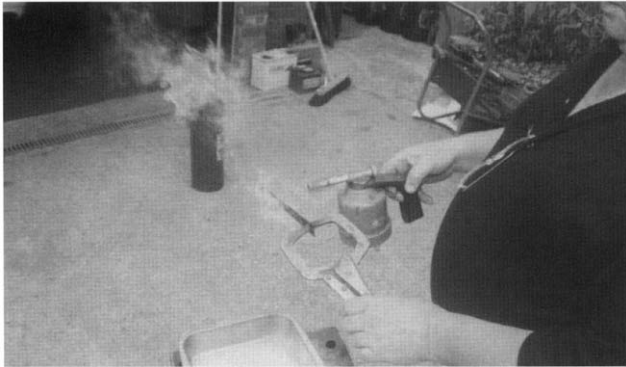
Carbon fibre resin required persistent flame presence to burn and was soon consumed. When the blowtorch was moved away, the flames extinguished themselves (Figure 4). Hence it was established that any ignition of leaked petrol vapours would have to be sustained for around five seconds and would have to have played directly onto fibre glass in order for the fire to catch hold. So where was the leak?

**Figure 4** Empirical test of combustibility of carbon fibre.

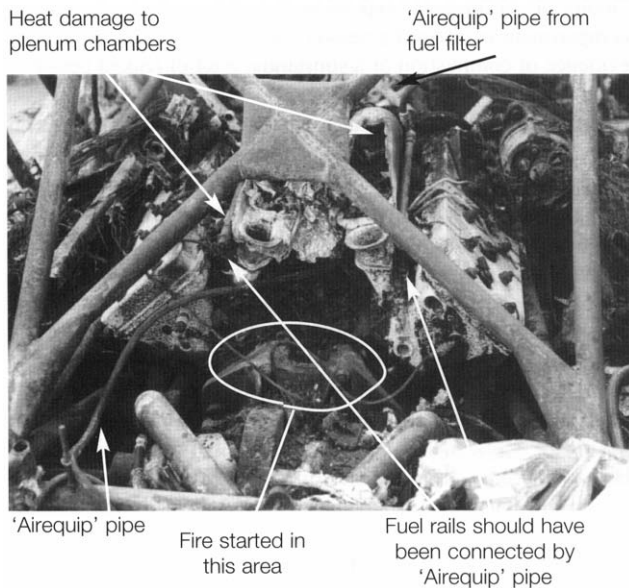
The bodywork of the car had burned to completion but aluminium components of the engine displayed clearly discernable patterns of directional heating (Figure 5). Care had to be taken when interpreting melting patterns to understand the thickness of the melted components and any heat sink effect of thick castings or steel components nearby.

**Figure 5** Damage to engine.

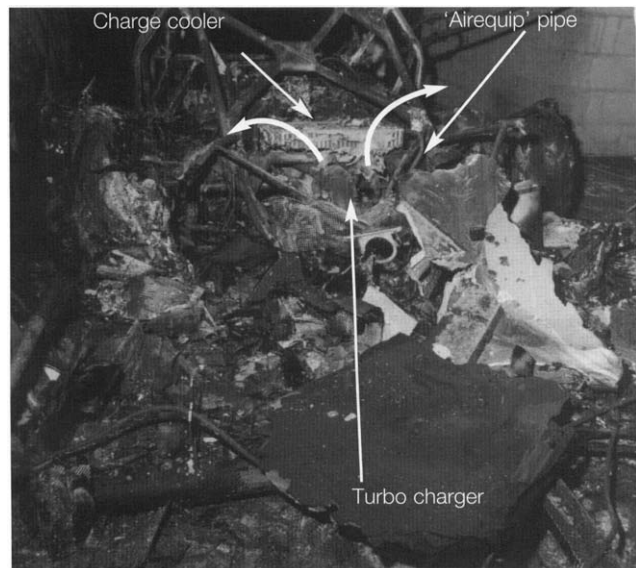
After much comparison of the photographs of the fire damaged car with the 'live' example it could be seen from the melting of fuel manifolds, air boxes and oil reservoirs that the fire had originated at low level between the engine and gear box, but not at such a low level as to affect the bottoms of tyres (Figures 6 and 7).

**Figure 6** Damage to rear of engine. Larger arrows show direction of fire spread.

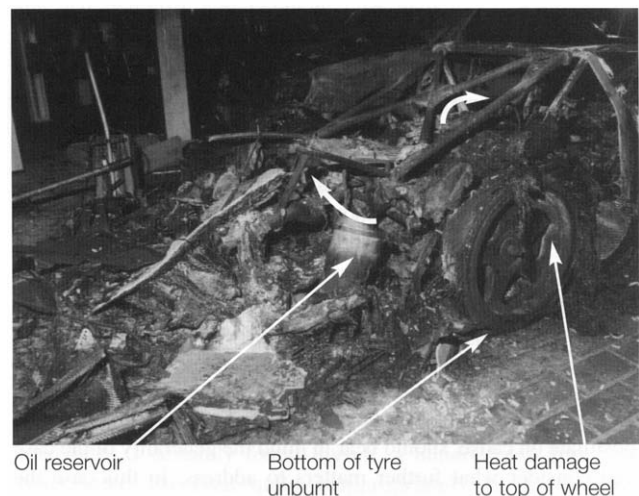
**Figure 7** Damage to rear of car. Larger arrows show direction of fire spread.

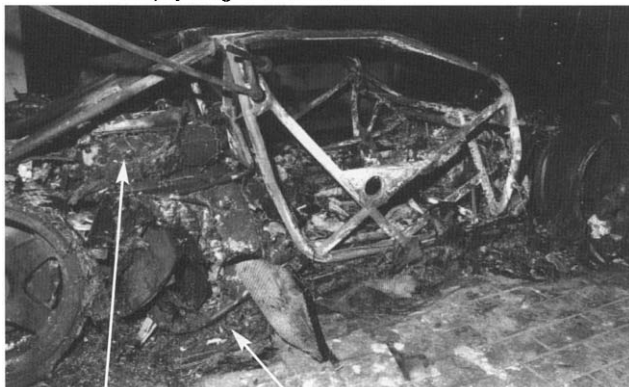
**Figure 8** Fuel cell had collapsed in the same way as an empty bag in a wine box.

Bramley had claimed that mechanics at the garage where he was working on the car had helped him re-fuel the car ready for testing the next day. There was no doubt that the mechanics had obtained the fuel for him but examination of the fuel tanks after the fire revealed that they were almost empty (Figure 8). Information obtained from the fuel tank manufacturers suggested that the woven nylon/polymer matrix fuel cells should have survived the fire. Re-examination of photographs of the fire damage showed that the fire had been reasonably confined to the

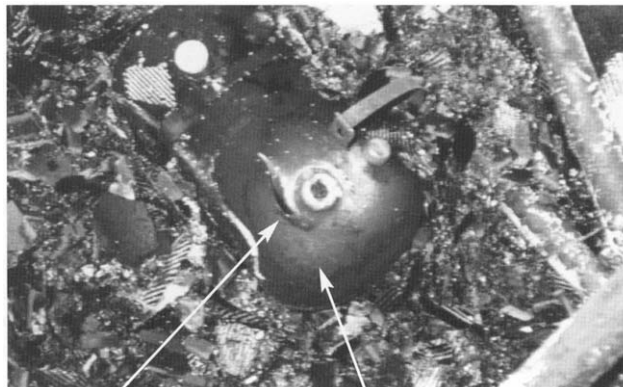
**Figure 9** Damage to fire extinguishant reservoir.

Bramley mentioned in his statement that he operated the car's on board fire extinguisher but it failed to extinguish the flames. Had he done so the extinguishant reservoir would have been depressurised and would have remained open to atmosphere. It could not have swelled and ruptured in the heat of the fire (Figure 9).
